Subject: Falk 2210YN2 Reducer Inspection in Virginia, USA MO#7-465680-01 for Pichichi Sugar Mill.

Field Service Inspection Report for Invoice # 111721-001 My Gear Man Company

Subject Inspection - #2 Falk 2210YN2-S, MO# 7-465680-01, 42.61:1 01/21-1974 140T10 HS Coupling. [LS SET WORN]

Subject Inspection- #1 Falk 2210YN2-S, MO# 7-465679-01, 42.61:1 (See Photo No1 by name plate #2 speed reducer [Recommend Purchase])

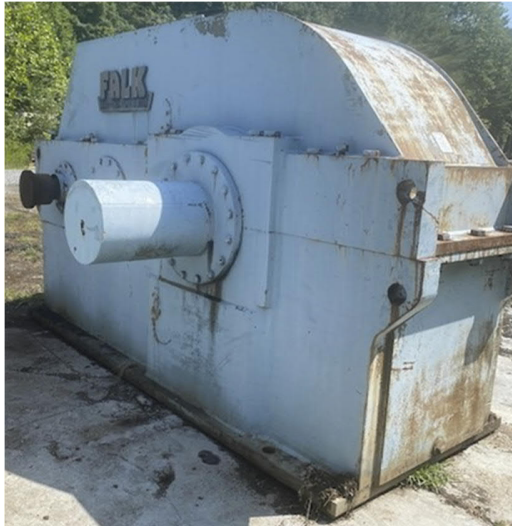
Photo No 2

EXTERIOR- The subject #1 Falk gear reducer needs an industrial grade paint job on its exterior before shipping. Customer (potential) recommends an Industrial Grade Paint in the Color of Blue (See photo No 2).

FOUNDATION/WELDMENTS- If there is time before painting exterior implement an NDT - Dry Crack Check (RED Dye Penetrant) on housing weldments and take photos before repainting the exterior.

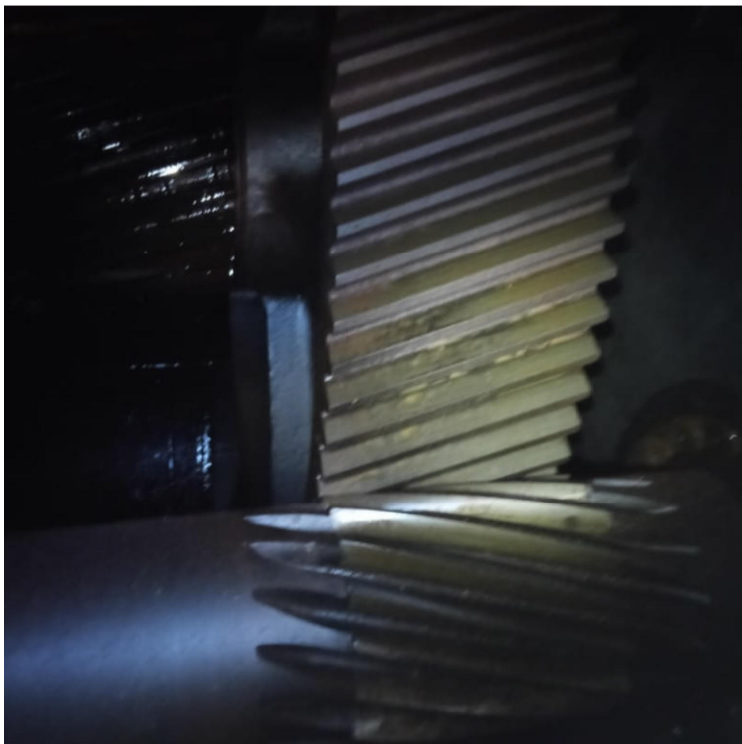
Photo No 3 HIGH SPEED GEAR #1 Inspection MO# 679-01

#1 HIGH SPEED PINION SHAFT ASSEMBLY- The tooth running contact is normal with no stress or abnormal wear is visually noted on any pinion tooth flanks on either the contact or pressure side of the HS Pinion teeth. It is very evident that this enclosed gear set has never been operated in the opposite direction of rotation. (See Photo No 3) PHOTOS HIGH SPEED GEAR #1 Inspection MO# 679-01.

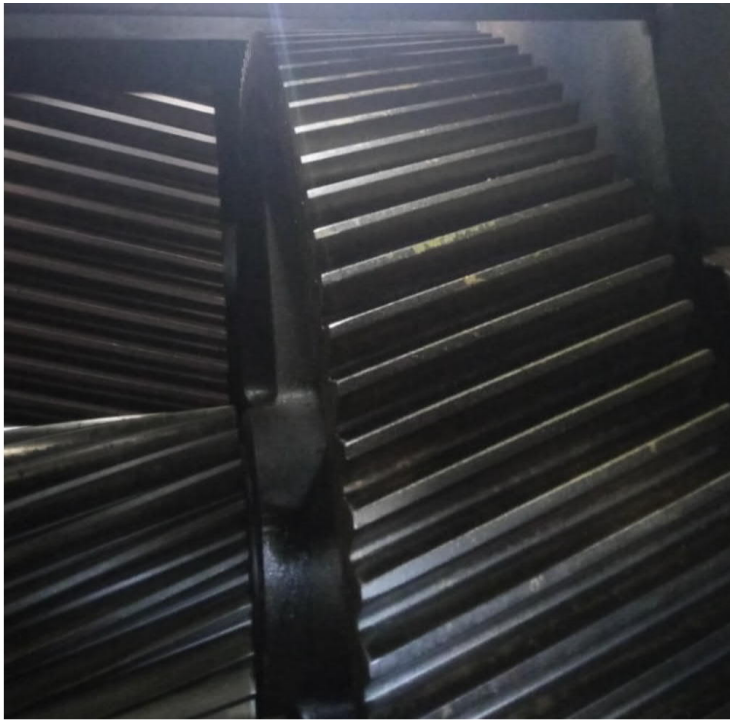
Photo No 4 HS GEAR MO#679-01

#2 HS GEAR PRESSED ON LOW SPEED PINION SHAFT ASSEMBLY- HS GEAR PRESSED ONTO -LS (SOS) PINION shows no abnormal or destructive wear on either tooth flanks. (The HS Pinion and HS Gear set in this subject Falk gear reducer has only been operated in one direction of rotation) (See photo No 4)

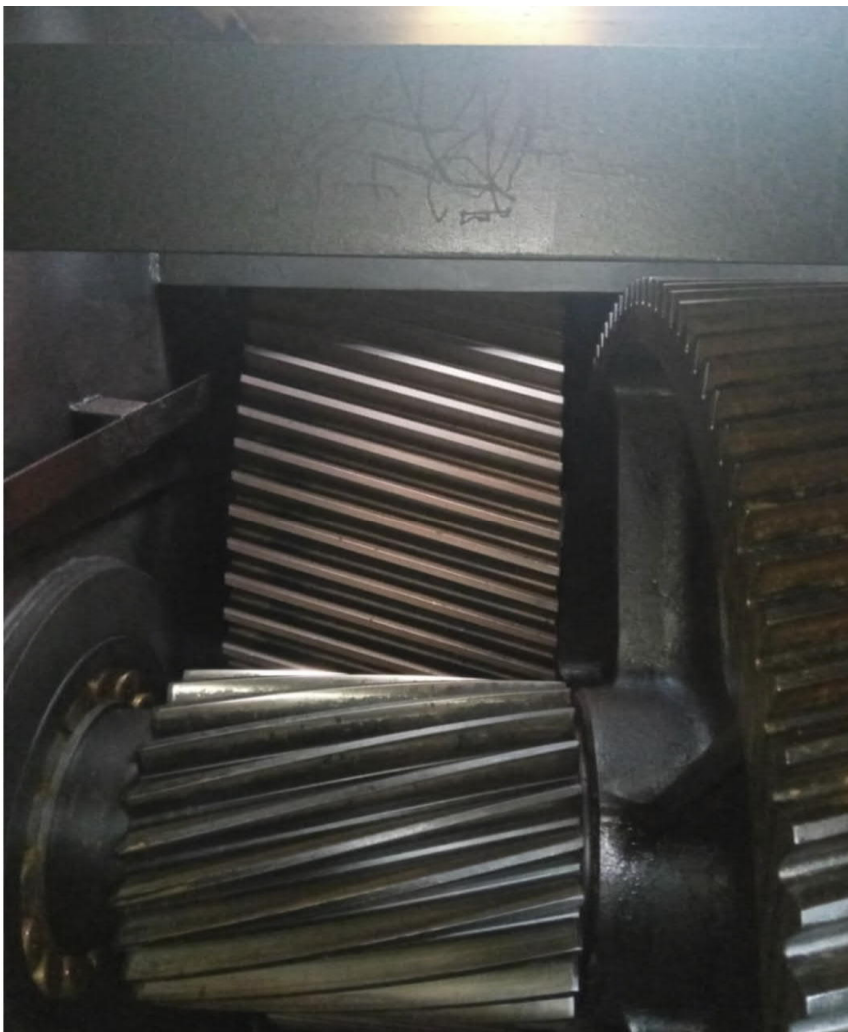
Photo No 5 (Low Speed gear and pinion speed reducer MO # 679-01

#2.1 The Low Speed (SOLID ON SHAFT/SOS) PINION-Has a slight amount of micro pitting or corrective pitting just below the pitch diameter on the Dedendum of (3) adjacent pinion driving teeth. This is a normal gear tooth wear occurrences for THROUGH HARNDENED and lapped gear sets that surface hardness is measured using the BRINELL Hardness Chart verses the Hardened and Ground Gear process that requires a Rockwell hardness measurement. When you are trying to compare pinion wear to gear wear, it important to use the right COMPONET measuring methods to identify the manufacturing process per part.)

THROUGH HARDENED GEARS normally wear at the dedendum or lower half of the pinion or gear teeth. It starts with micro pitting and it accumulated in mass over time until the whole dedendum is washed away or out. This normal process is called 'WASHOUT" and it is a normal occurrence for this gear manufacturing process. A gear or pinion is considered "WORNOUT" when the dedendum "WASHOUT" exceeds .025" in depth across its full-face width. [#2 Reducers looks bad but, I would guess that the washout depth doesn't exceed .010" at its worst point across 40% of its face width. (See photo No 5) #1 LS pinion wear pattern.

(SEE PHOTO OF LS PINION #2 Inspection verses LS PINION #1) The #2 (680-01) has what I will call 20% "Dedendum Washout" on 1 side of the LS pinion tooth flank and the other side is like new. The #1 Reducer has .001% corrective or micro-pitting "DEDEMNUM WASHOUT" and the other side is new!
