## PILES UNDERWATER INSPECTION

Date: 07/04/2023

P - 05

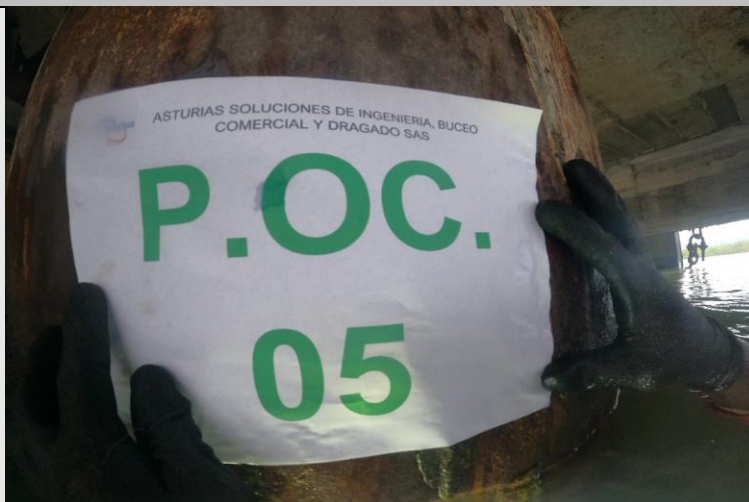
Image 1: Pile - nomenclature P-05

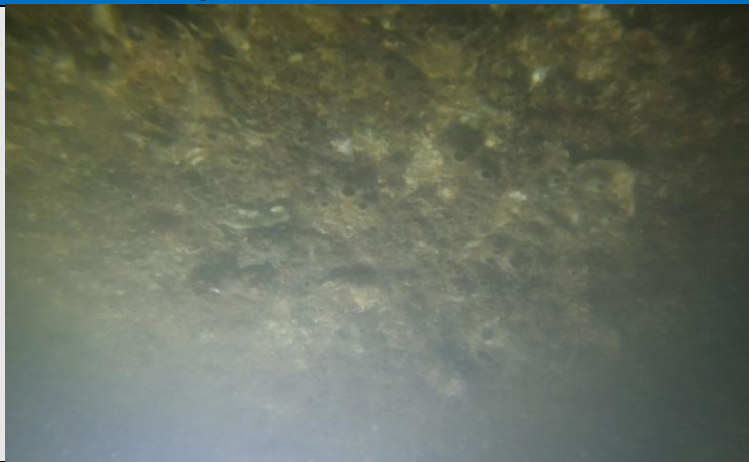
Image 2: Pile P-05 Below tide level covered largely by organisms.

| Severe Damage | | | | | Loss of cross - sectional area, or evaluate material | | | |
|---|---|---|---|---|---|---|---|---|
| Observations: There is evidence of porosity, and corrosion on the steel coating surface. | | | | | Observations: there is no evidence of loss material. | | | |

| Surface defects normally obscured by marine growth | | | | |
|---|---|---|---|---|
| Observations: The structure is completely covered by marine growth | | | | |

| ELABORATED BY ASTURIAS INGENIERIA | DIVING SUPERVISOR | VoBo | OBSERVATIONS |
|---|---|---|---|
| Lead Diver: Piter Cuero | Juan D. Zapata Chacon | Camilo A. Chacon | No serious damages or cracking were found both on the surface and below tide levels. |
