PILES UNDERWATER INSPECTION

Date: 07/04/2023

P - 08

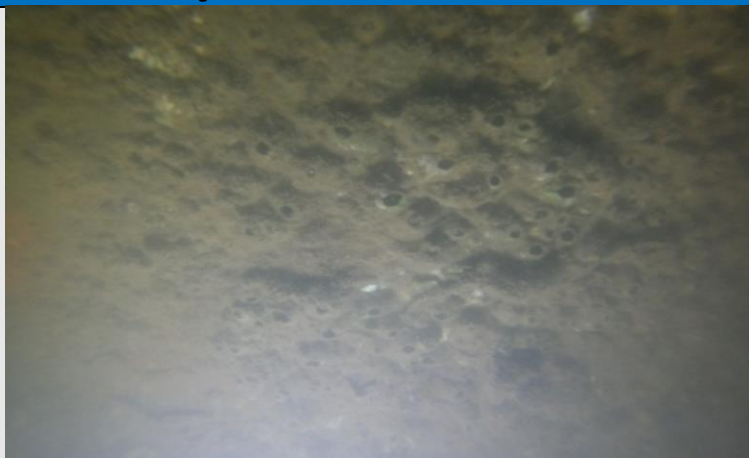
Image 2: Pile P-08 Below tide level covered largely by organisms.

Observations: The structure is completely covered by marine growth

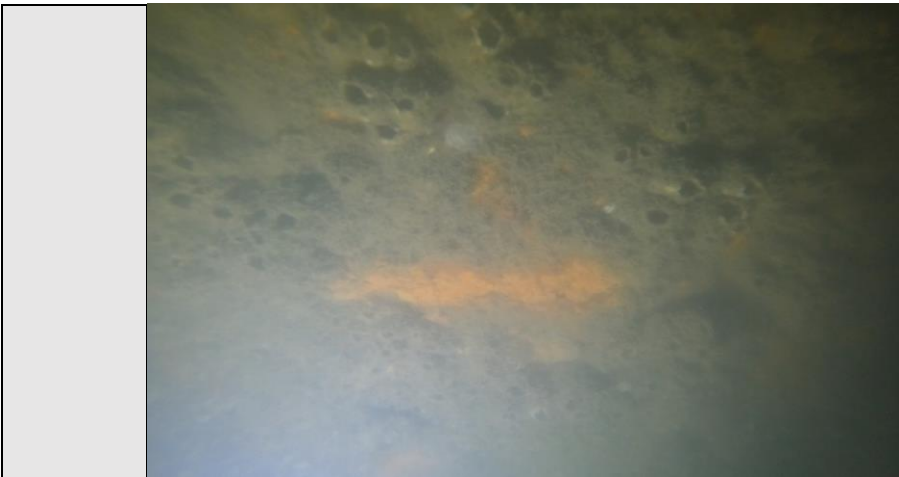
Image 3: Pile P-08 covered by marine organisms and corrosion on patches.

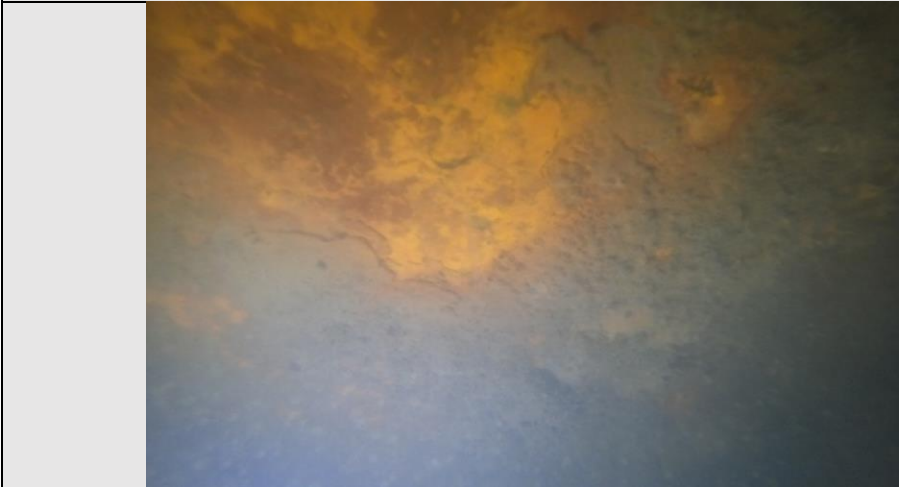
Image 4: Pile P-08 metal expose with presence of corrosion and porosity.

Observations: There is evidence of porosity, and corrosion on the steel coating surface.

Observations: there is no evidence of loss material.
