## PILES UNDERWATER INSPECTION

Date: 07/04/2023

P - 05

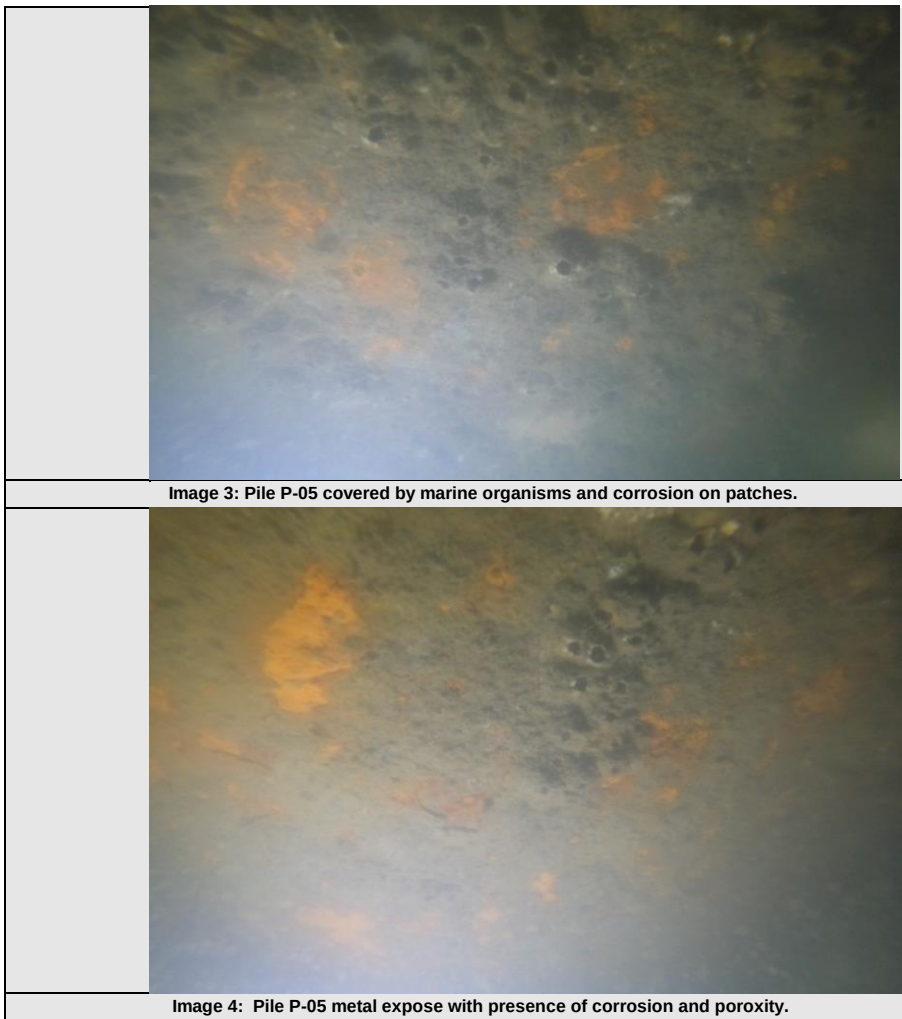
| Severe Damage | | | | | Loss of cross - sectional area, or evaluate material | | | |
|---|---|---|---|---|---|---|---|---|
| Observations: There is evidence of porosity, and corrosion on the steel coating surface. | | | | | Observations: there is no evidence of loss material. | | | |

| ELABORATED BY ASTURIAS INGENIERIA | DIVING SUPERVISOR | VoBo | OBSERVATIONS |
|---|---|---|---|
| Lead Diver: Piter Cuero | Juan D. Zapata Chacon | Camilo A. Chacon | No serious damages or cracking were found both on the surface and below tide levels. |
